TO REPAIR, OR NOT TO REPAIR?

OUR RESIDENT EXPERT GUNSMITH HAS BEEN INUNDATED WITH QUESTIONS AND REQUESTS FOR STOCK REPAIRS AFTER HIS PREVIOUS ARTICLE, SO HERE HE GIVES US MORE EXAMPLES AND DETAILS OF HIS MIRACLE WORK

By Tim Greenwood

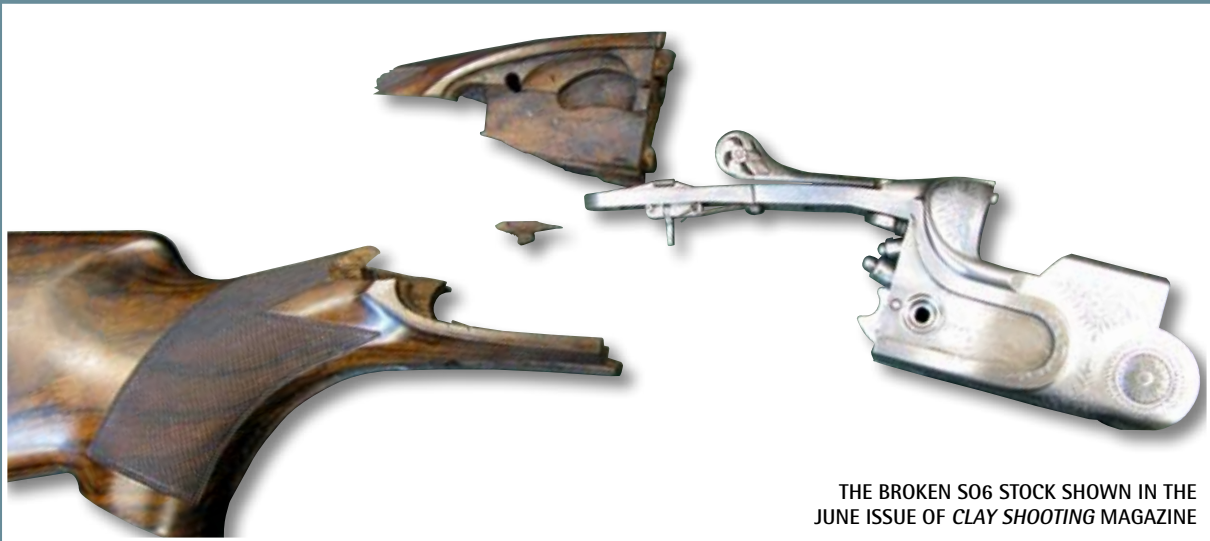
THE BROKEN SO6 STOCK SHOWN IN THE JUNE ISSUE OF *CLAY SHOOTING* MAGAZINE

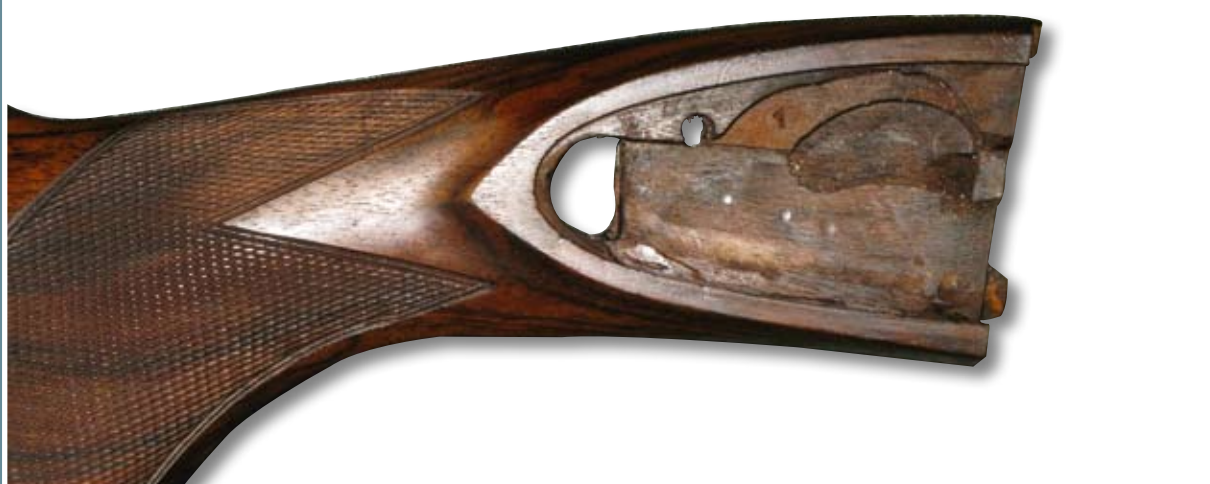
GOOD AS NEW – THE REPAIRED STOCK

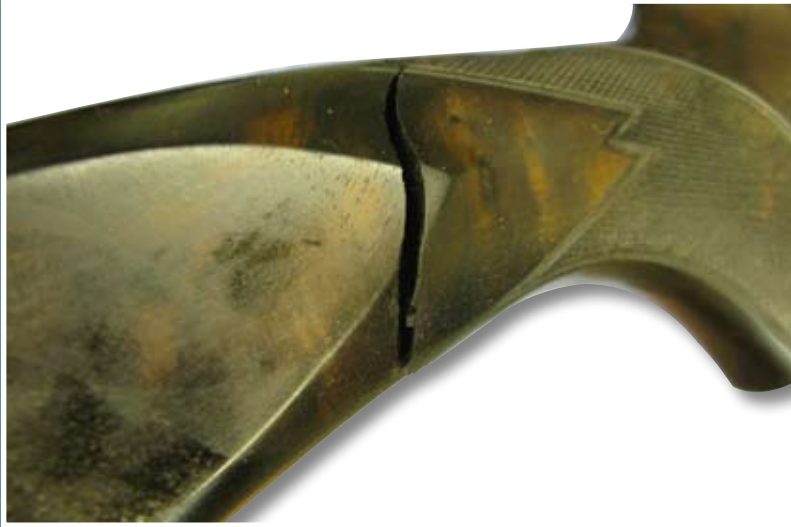
The damaged stock in this picture and the one below belong to a Browning 525 o/u 12b. Apart from the head of the stock being full up with action oil, which softens the timber, the main damage has been caused by someone casting the stock to left hand without relieving the head or the draw bolt hole. This major crack is the result.

A REALLY BAD BREAK CAUSED BY POOR STOCK CASTING TECHNIQUE. NOTICE THE OIL OOZING FROM THE WOOD DUE TO OVER-OILING AND THE GUN BEING STORED STOCK DOWN

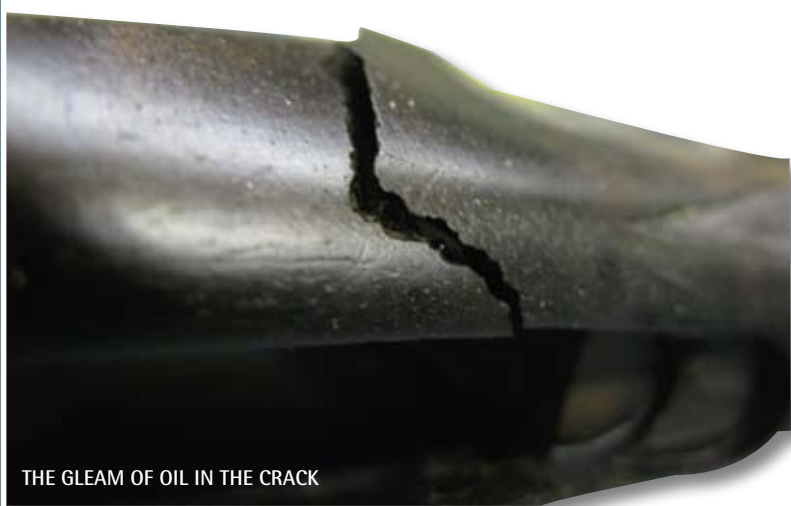
THE GLEAM OF OIL IN THE CRACK

If you look carefully you can see how open the grain is in the head of the stock, and the glisten of the mineral oil in the crack. Before attempting the repair it is essential to extract as much of this oil from the stock as possible.

There are many ways of doing this but my favourite is to either wrap the head in kitchen roll and put it in the airing cupboard, or to gently steam the area, wiping off the oil as it bleeds from the wood, then leave to dry.

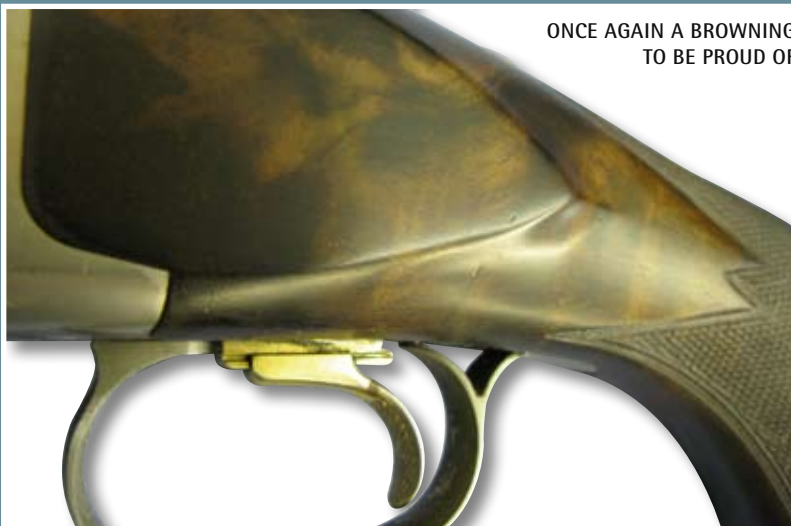
ONCE AGAIN A BROWNING TO BE PROUD OF

Once the crack and head are as free from oil as possible, industrial strength Cyanoacrylate glue is injected into the crack; the stock is then bolted back onto the action (applying a suitable releasing agent to the action first) then clamped to set overnight.

After releasing the stock from the action any excess glue is removed; the area is rubbed down, being careful not to change the profile. This picture shows the result after re-finishing.

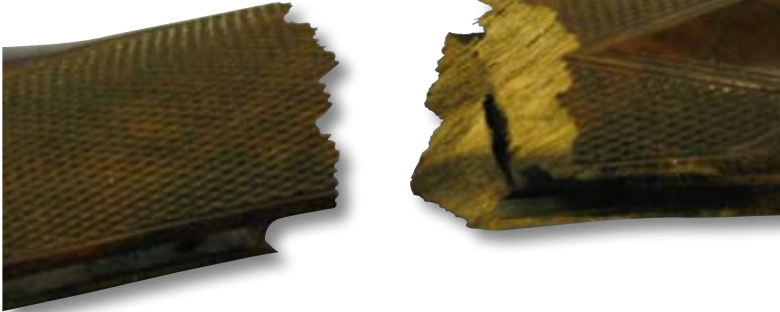
THE BROKEN HAND OF A CLASSIC ENGLISH BOXLOCK

The next repair, however, was a lot harder to undertake. This picture shows a rather expensive English boxlock, with the stock snapped through the hand.

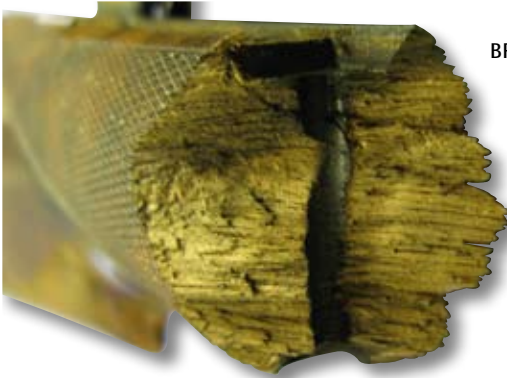
THE CROSS-SECTION OF THE BREAK. LOOK HOW FIBROUS THE GRAIN IS AND THE DIRECTION ACROSS THE GRIP

It is interesting to see, under closer examination, that the grain through the break is very dry, open and running the wrong way to give maximum strength through the thinnest part of the stock. It is always ideal for the grain at this point to run from the stock head (the action end) towards the butt. It is lovely to see highly figured wavy grain in a stock, but not through the grip. There is an old saying in stocking – “straight is strong”.

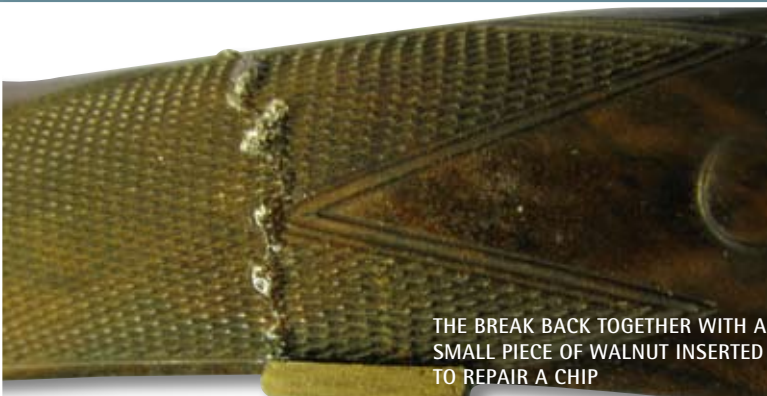
THE BREAK BACK TOGETHER WITH A SMALL PIECE OF WALNUT INSERTED TO REPAIR A CHIP

The first part of the repair, as shown here, was to fit the two halves back together in as near perfect alignment as possible, using, once again, Cyanoacrylate.

I also took the opportunity to fit small pieces of walnut into the chipped areas around the break. Once again, if the wood is full of mineral oil it is essential to remove as much as possible to ensure a good repair

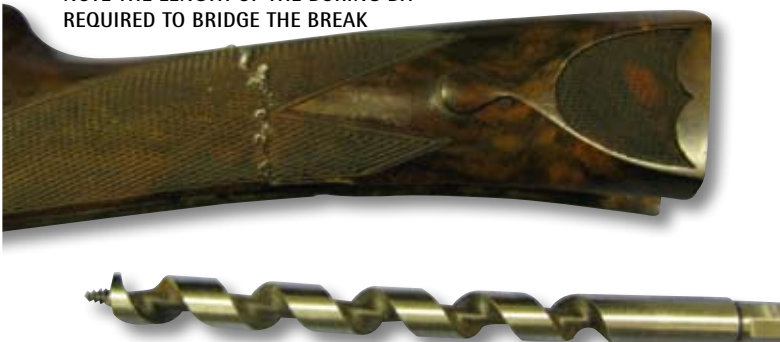
NOTE THE LENGTH OF THE BORING BIT REQUIRED TO BRIDGE THE BREAK

However, due to the small surface area, and the weakness in the grain, a simple glue repair would not do. The next stage was to bore a hole from the head of the stock, down through the action inletting and through the grip to bridge the break. This whole operation has to be carried out slowly by hand so you can feel the response of the stock. A great deal of care is needed to not break open the crack repair or cause more damage.

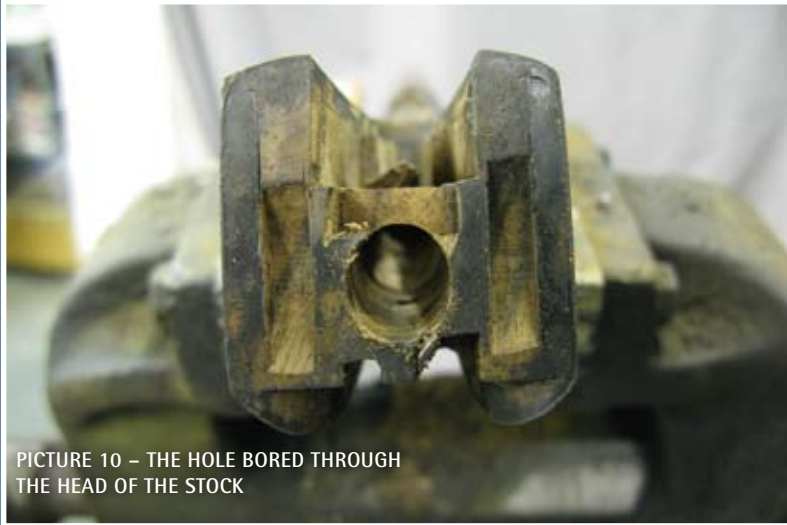
PICTURE 10 – THE HOLE BORED THROUGH THE HEAD OF THE STOCK

I have to confess, this is the part of the repair operation that I find most nerve-racking. It is always with a sense of relief to see a nice, straight bore hole when the auger drill bit is removed. You can feel the grip flexing as the bit cuts into the wood at this point. A little too much pressure to the cutter can destroy the head, splintering the inletting and destroying the wood to metal fit when the gun is re-assembled, or worse still, you could cause a longitudinal crack from the head down through the grip, weakening the whole repair.

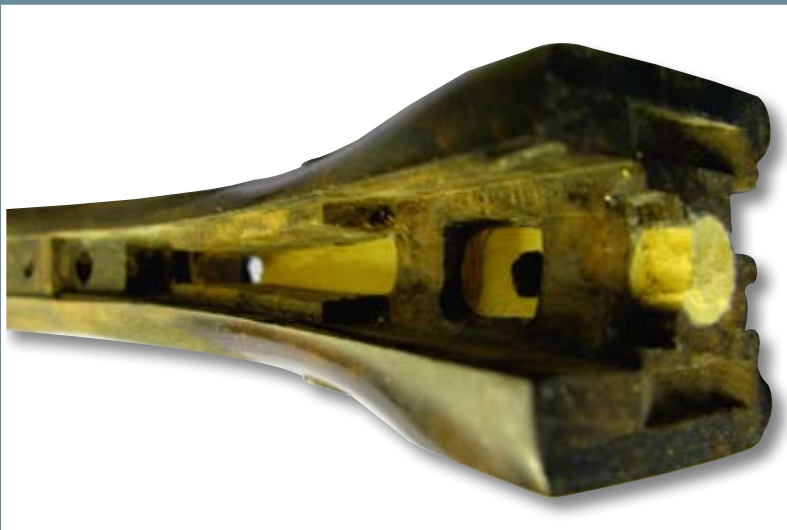
THE DOWEL INSERTED AND HEADED UP FOR THE ACTION

Once the hole has been bored a 15mm hardwood dowel, usually beech, is inserted into the hole and bonded in place with a two pack industrial resin, therefore bridging the break and adding considerable strength through the grip.

Finally, in this part of the operation, the head has to be re-inletted to accept the action, as shown in this picture

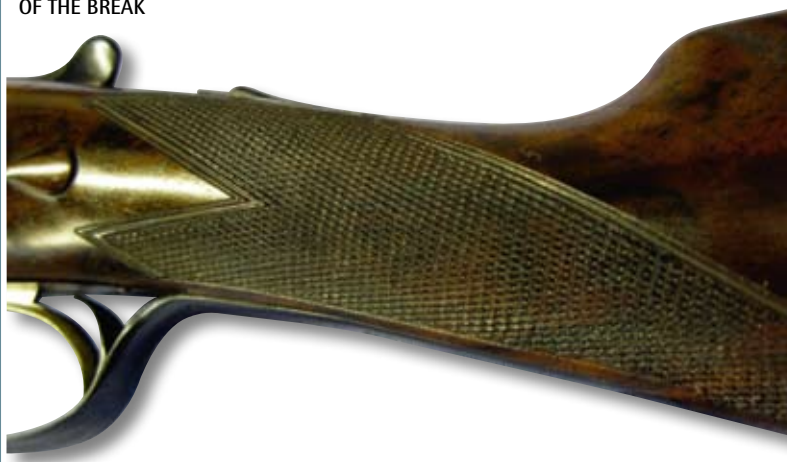
ALL FINISHED AND NOT A SIGN OF THE BREAK

After re-assembling the gun to check that the inletting was correct and the action functioned correctly, the stock was once again taken off the action for finishing. The excess glue had to be removed and the replacement wood fitted to the chipped areas had to be shaped by rasp then sanding.

Finally, the chequering had to be picked up and reproduced over the damaged area. As you can see, with a little colour matching and re-finishing, the repair is nearly impossible to see and, due to the hidden dowel, very strong.
