TO REPAIR, OR NOT TO REPAIR?

OUR RESIDENT EXPERT GUNSMITH HAS BEEN INUNDATED WITH QUESTIONS AND REQUESTS FOR STOCK REPAIRS AFTER HIS PREVIOUS ARTICLE, SO HERE HE GIVES US MORE EXAMPLES AND DETAILS OF HIS MIRACLE WORK

By Tim Greenwood

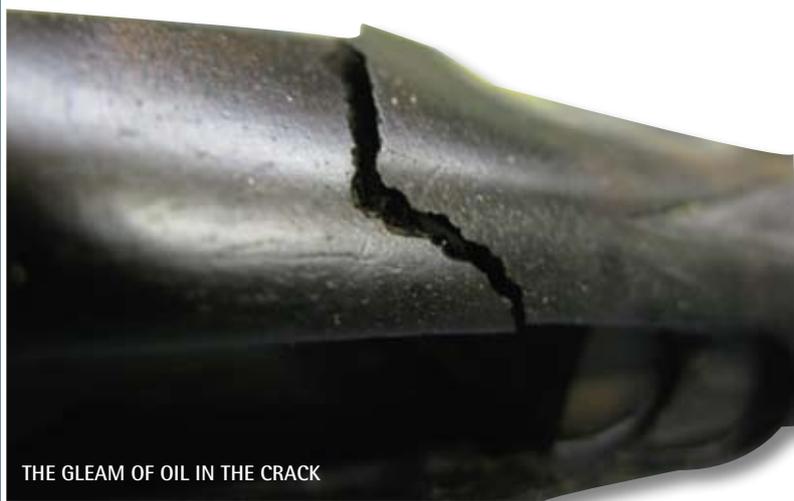
THE GLEAM OF OIL IN THE CRACK

If you look carefully you can see how open the grain is in the head of the stock, and the glisten of the mineral oil in the crack. Before attempting the repair it is essential to extract as much of this oil from the stock as possible.

There are many ways of doing this but my favourite is to either wrap the head in kitchen roll and put it in the airing cupboard, or to gently steam the area, wiping off the oil as it bleeds from the wood, then leave to dry.

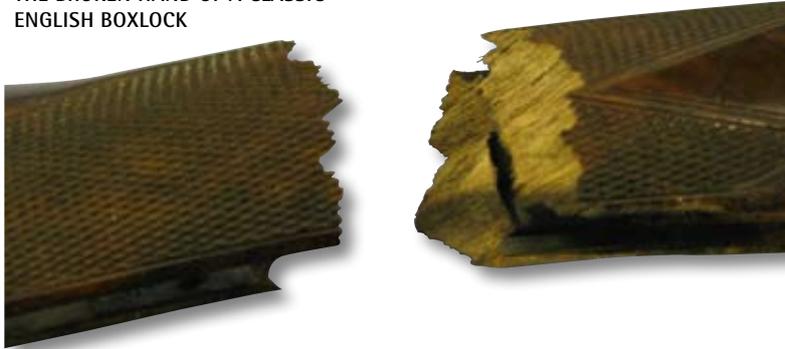
THE BROKEN HAND OF A CLASSIC ENGLISH BOXLOCK

The next repair, however, was a lot harder to undertake. This picture shows a rather expensive English boxlock, with the stock snapped through the hand.

The gun had only been re-stocked three years ago, at considerable cost and inconvenience to the client, as the stocker took two years to complete the work.

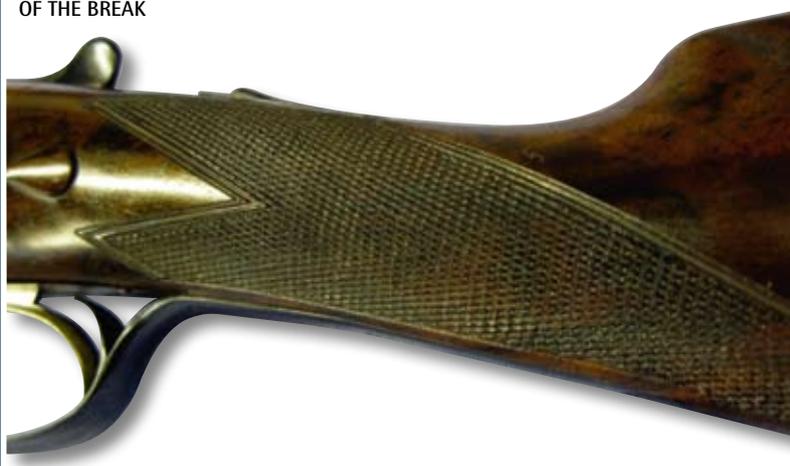
ALL FINISHED AND NOT A SIGN OF THE BREAK

After re-assembling the gun to check that the inletting was correct and the action functioned correctly, the stock was once again taken off the action for finishing. The excess glue had to be removed and the replacement wood fitted to the chipped areas had to be shaped by rasp then sanding.

Finally, the chequering had to be picked up and reproduced over the damaged area. As you can see, with a little colour matching and re-finishing, the repair is nearly impossible to see and, due to the hidden dowel, very strong.
